# Manhole Inspection Summary

Manhole # S55S\_\_011MH

Insp Date: **7/22/08 10:11 AM**

**Location** Address: **1516 s highland av**

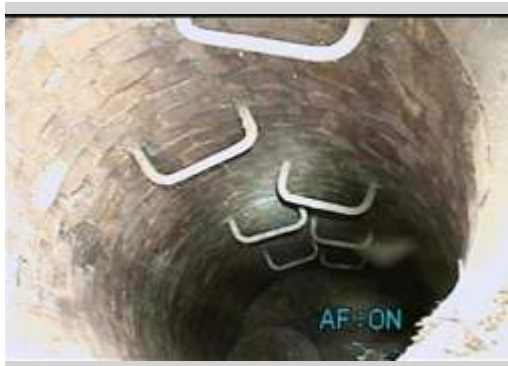
Miscellaneous

steps

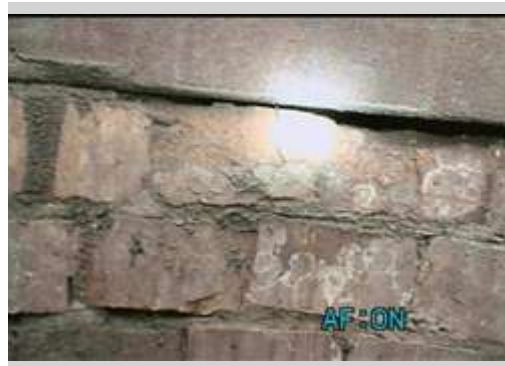
Defect 1

Condition: ☐ Sound ☐ Cracked ☐ Root Intrusion ☐ Loose Brick ☒ **Deteriorated**

Corbel deteriorated;  
frame adj

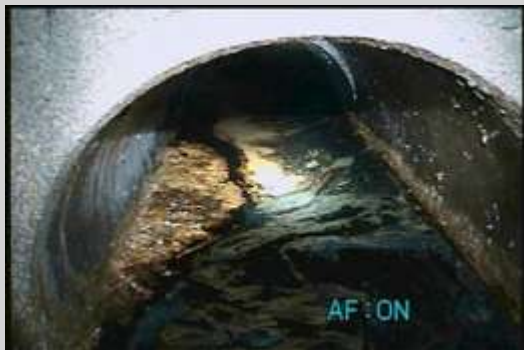
12 O'Clock Outflow

couldnt get better pic not enough space to get all of the pipe in

Deposits: ☐ None ☐ Mud ☒ Sludge ☐ Debris ☐ Grease

Silt Depth: 11 (in.) Deposits Extent: Medium

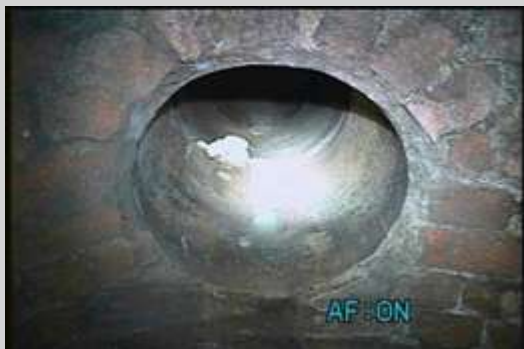
5 O'Clock Inflow

Deposits: ☐ None ☐ Mud ☐ Sludge ☒ Debris ☐ Grease

Silt Depth: 6 (in.) Deposits Extent: Medium

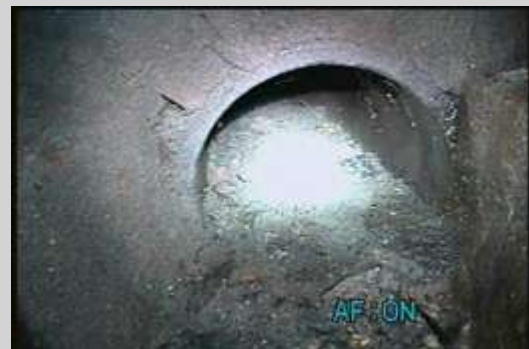
Drop In @ 5 OClock

Drop: Outside Direct

Drop Condition: Open

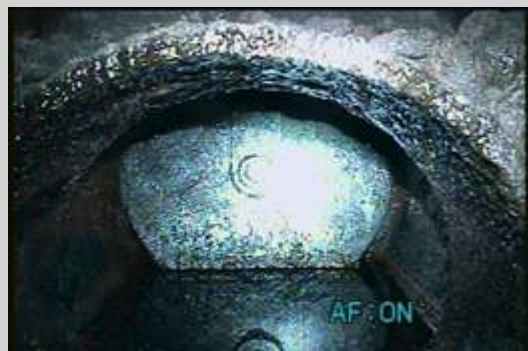
9 O'Clock Inflow

Deposits: ☒ None ☐ Mud ☐ Sludge ☐ Debris ☐ Grease

Connects To: **Dead End**
